DOCUMENT NO. T5-6539-103

TITLE ANALYSIS OF TOOLING BOSS WELD FAILURE IN THE LOWER BULKHEAD
OF THE S-IC-S FUEL TANK

MODEL NO. SATURN V/S-IC CONTRACT NO. NAS8-5608

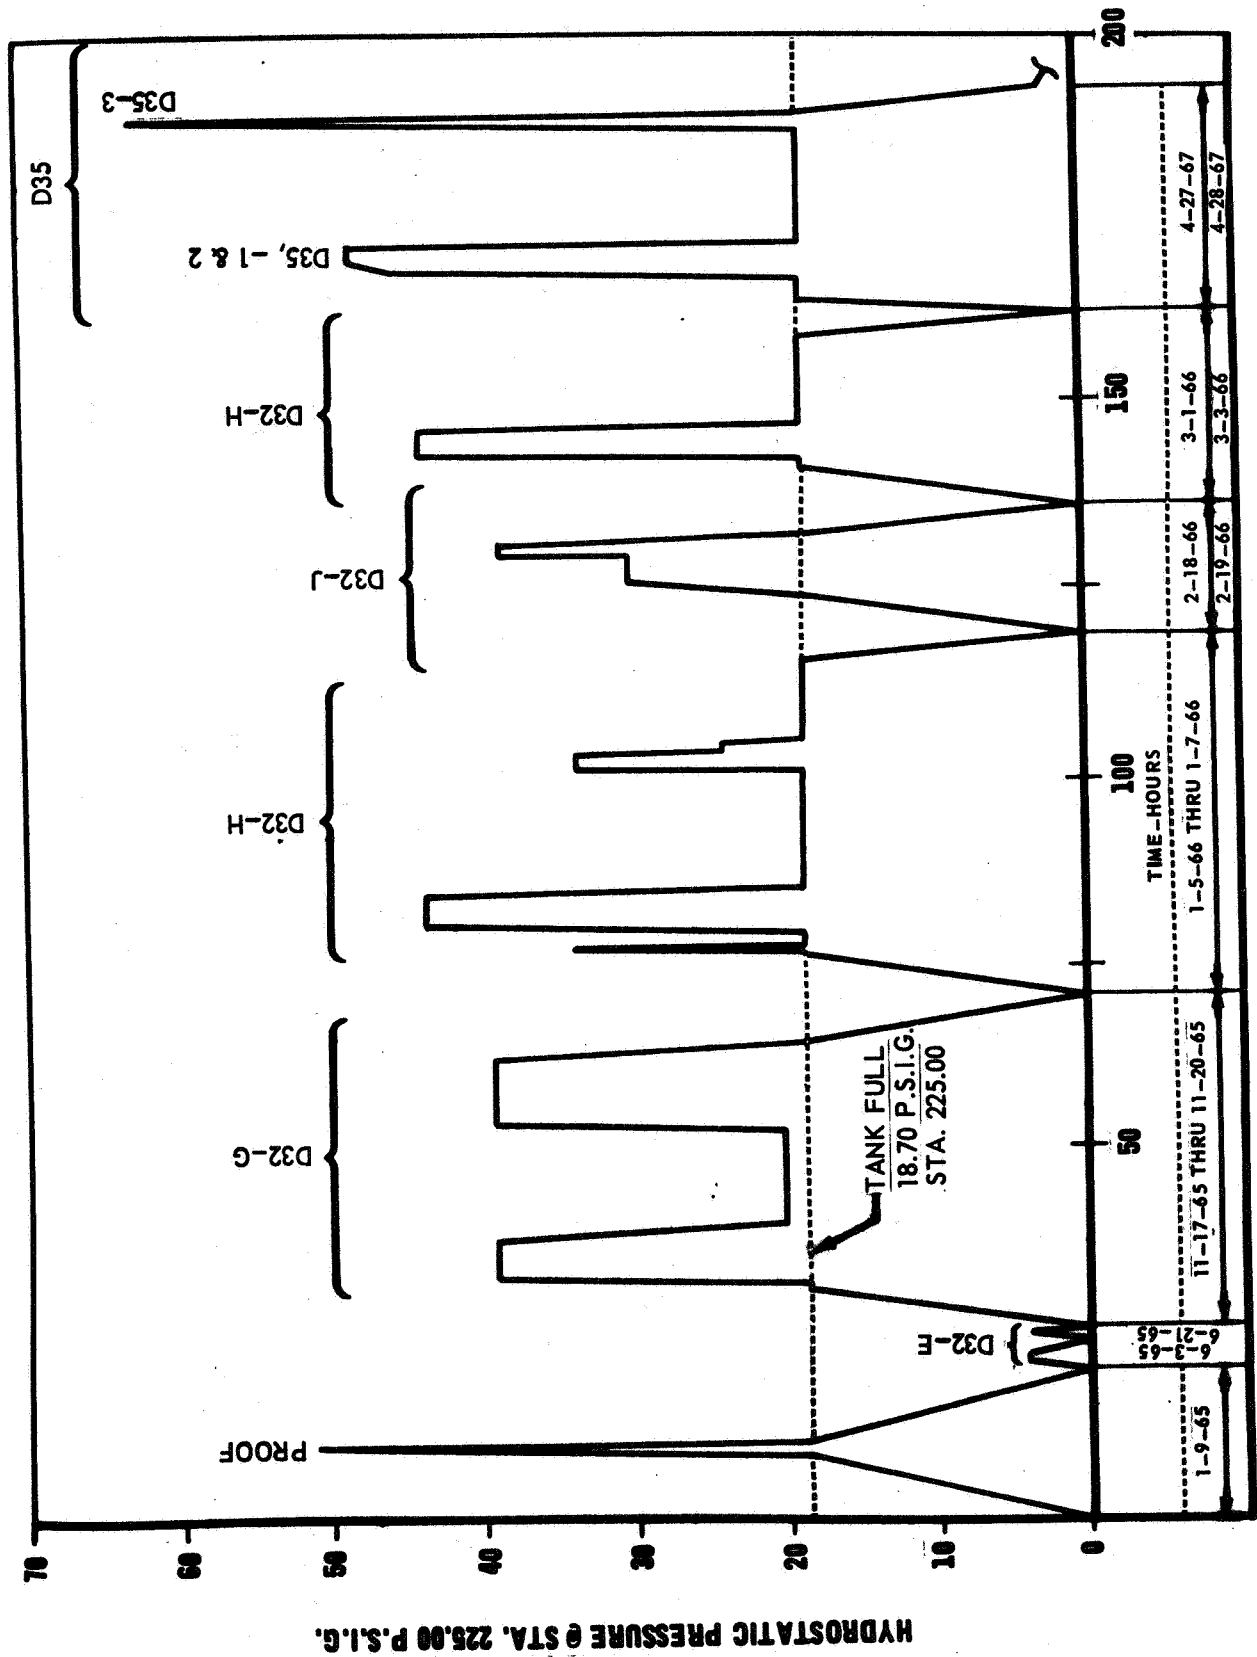
FIG. 1 S-IC-S FUEL TANK COMPOSITE LOG

Figure 1 is a testing log for the S-IC-S Fuel tank as reported in D5-11973 "S-IC Stage Major Structural Test Program"

The presence of much porosity in the weld and the use of extreme heat during multiple repair welding lowered the properties of the weldment to such an extent that it could not withstand the Ultimate Test Pressure of 62.5 psig after pressure cycling as shown in Figure 1. It is probable that the condition of this weld was unique to the S-IC-S Fuel Tank.

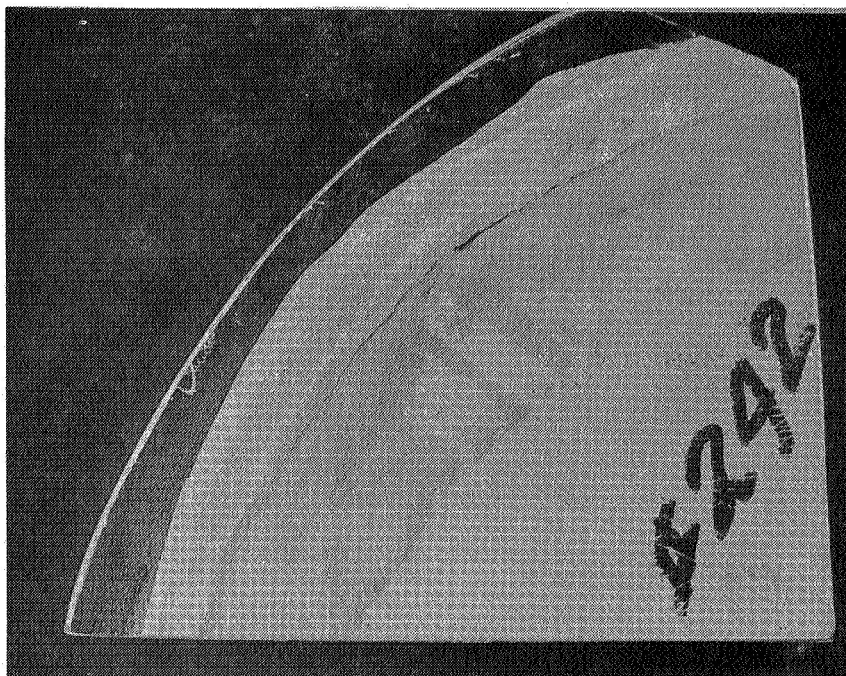
FIGURE 2 - WELD SPECIMEN FROM TOOLING BOSS 1X

The weld specimen used in this analysis, Figure 2, was located in the tooling boss weld as shown in Figure 3. After x-raying the specimen, the fracture was broken open Figure 4 and the faces examined using a wide field stereoscope. Figure 5 shows two areas containing corrosion products and debris typical of the entire fracture length. Fracture origin could not be determined because of this condition. The x-ray indication of the crack was so massive that it obscured any other possible defects, Figure 6.

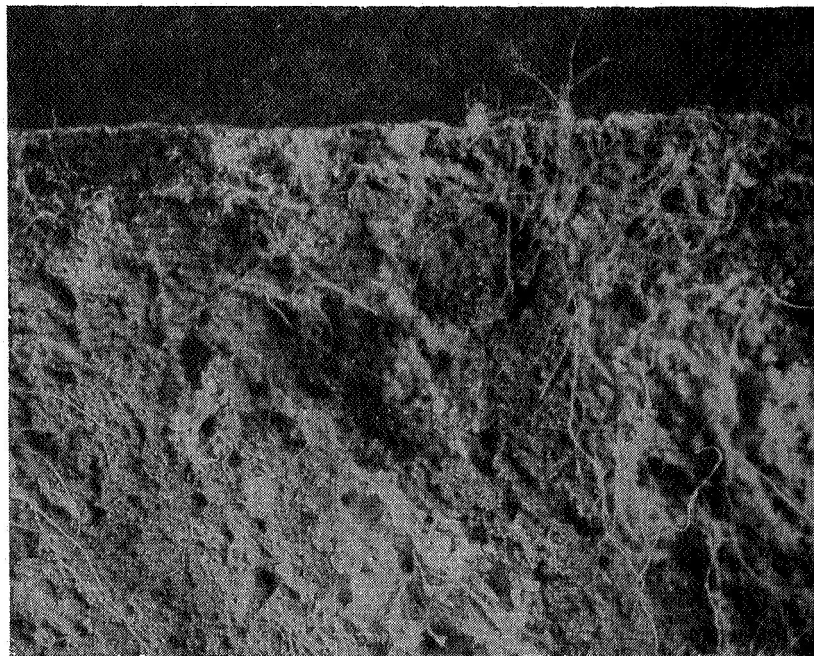
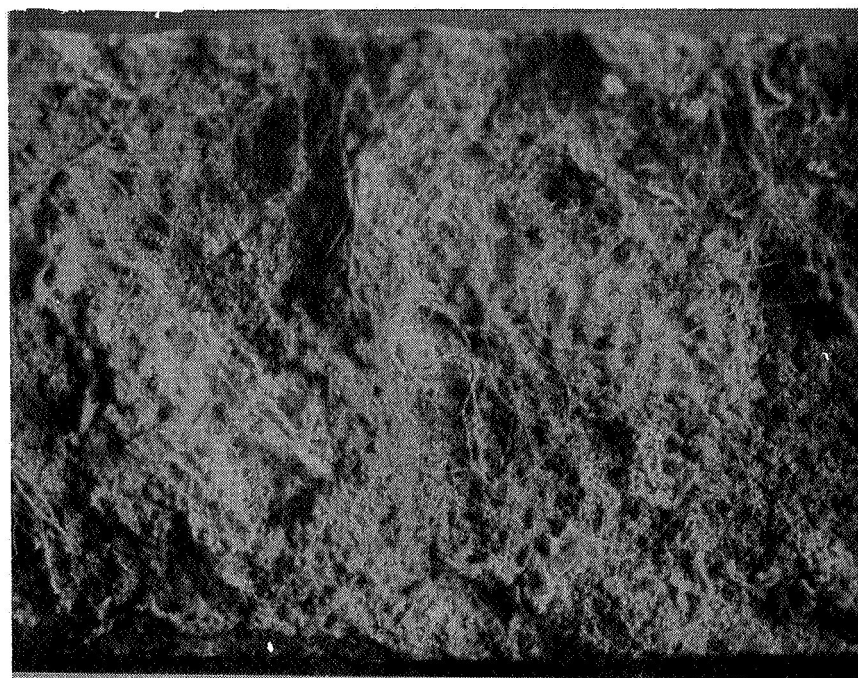
FIGURE 5 - FRACTURE FACE CORROSION AND DEBRIS

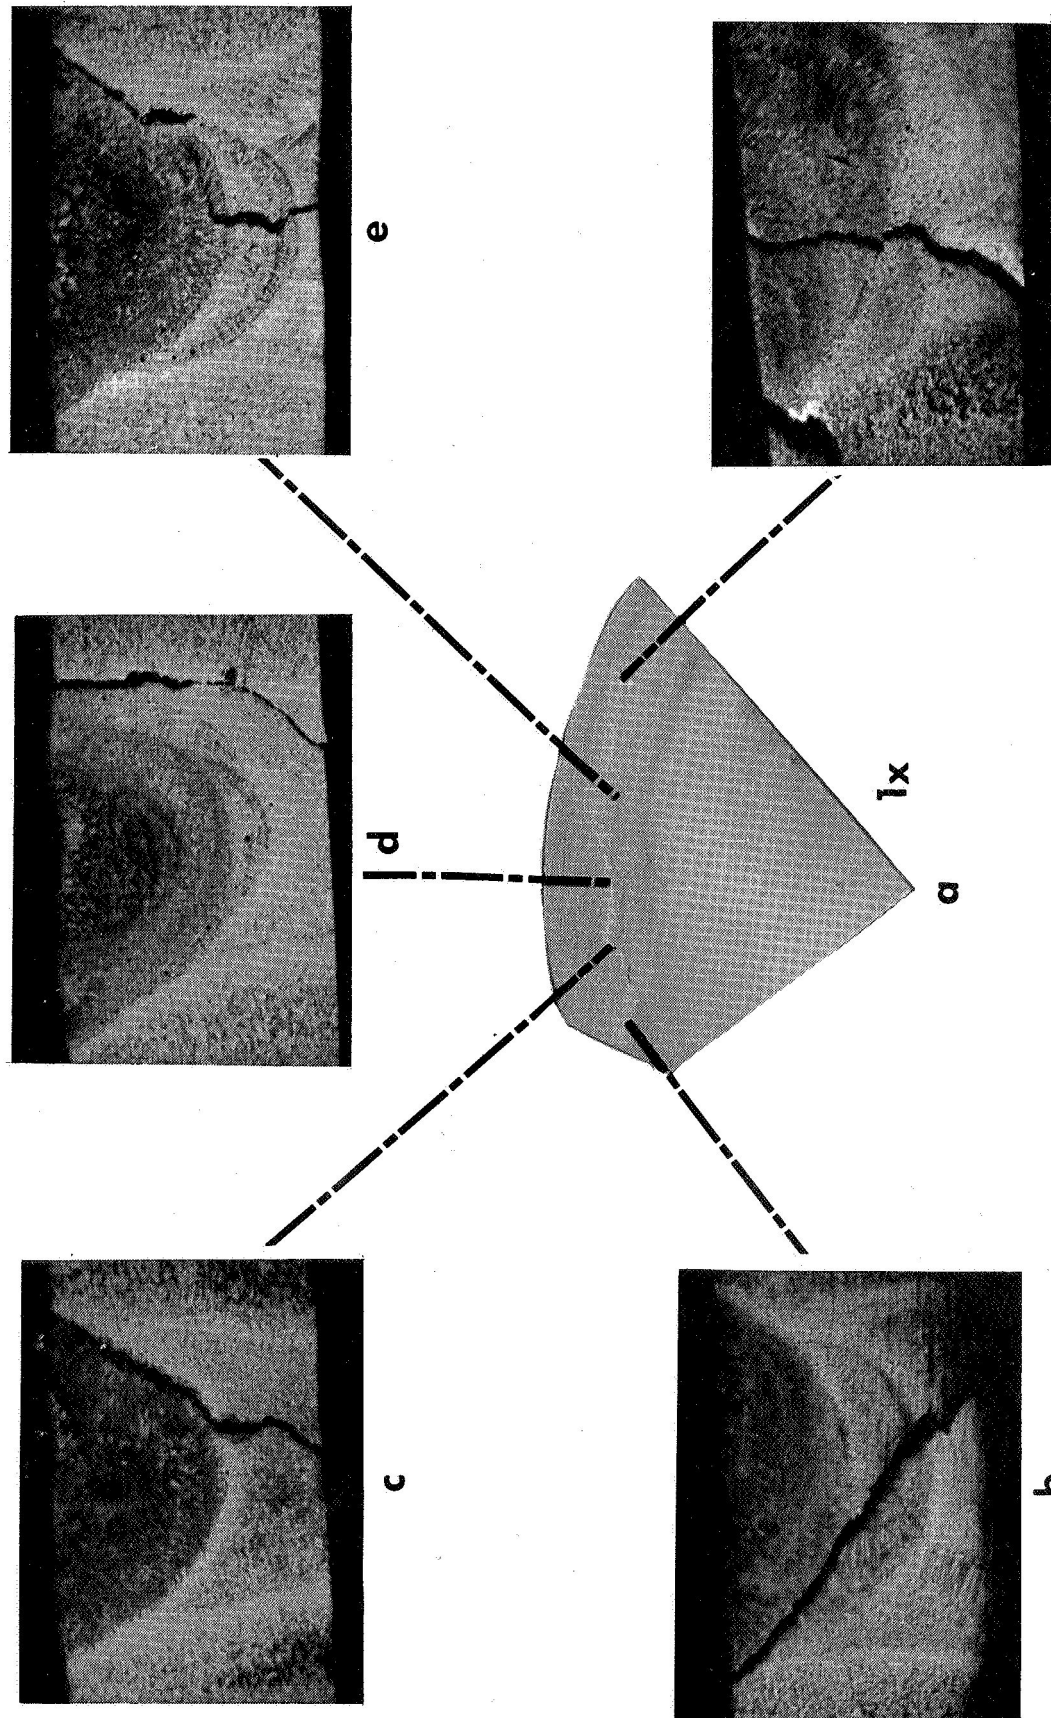
Fig.7 Macrographs of weld at several locations

The weld specimen was sectioned as shown in Figure 7a and the macrographic findings are illustrated by Figures 7b through 7f inclusive. It can be noted that the weld has been repaired one or more times dependent on location and considerable porosity is evident in figures nos. 7d, e and f. The conditions present in the right end of the weld suggest that the fracture origin occurred between 7d and 7f.

Since all of the stages (501 through 504) which contain the welded tooling boss have been adequately inspected, proof tested and captive fired, sufficient confidence should be placed in the current satisfactory condition of these welds and capability to sustain anticipated pressures. (Subsequent vehicles contain a mechanically fastened boss which is considered more reliable.)

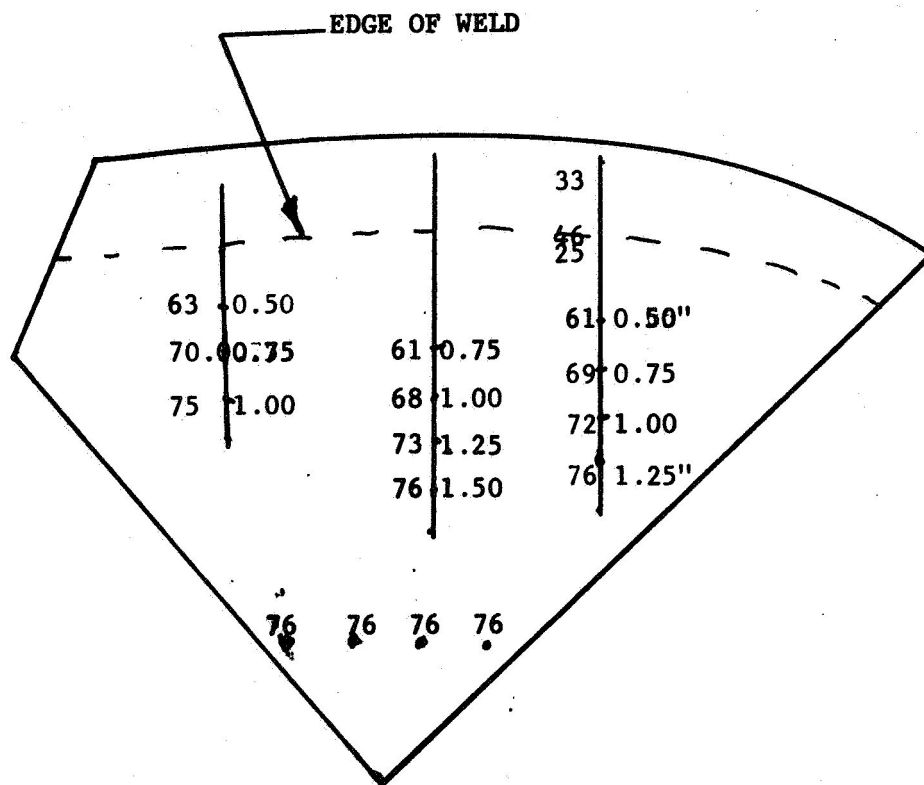
FIGURE 8 - HARDNESS READINGS R_b

Hardness tests at four locations were made from the center-line of the weld out into the base metal to determine at which point base metal properties were recovered. Figure 8 contains the results of four traverses and reveal that recovery, R_c 76, is between 1.25 and 1.50 inches from the weld. This indicates that extreme heat was used in making the weld and weld repairs which in conjunction with the aforementioned porosities, lowered the mechanical properties of this weldment sufficiently to allow failure under Ultimate Test Pressure conditions.
